DISTRICT No.2 SCHOOL

TOWN OF CAROLINE
TOWN HALL

Slaterville Springs, NY
Historic Structures Report

Prepared by Sam Coons

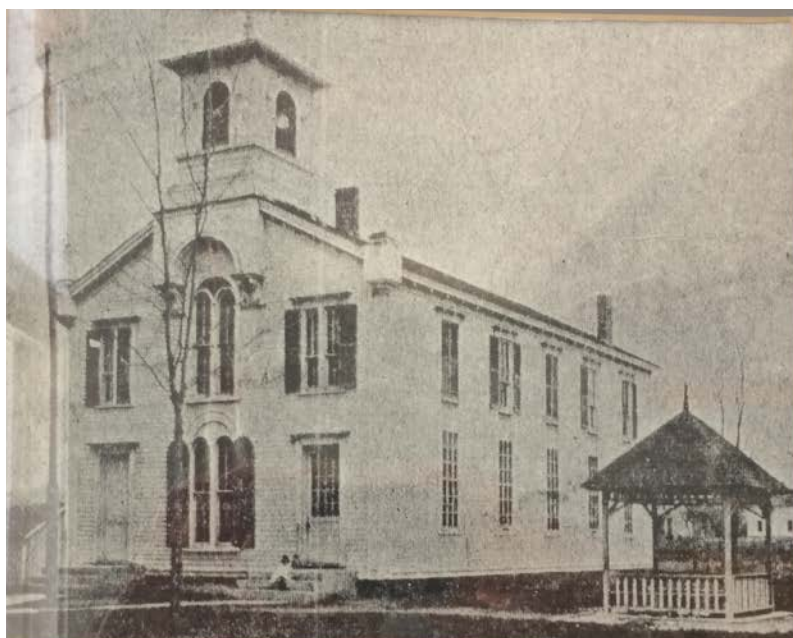
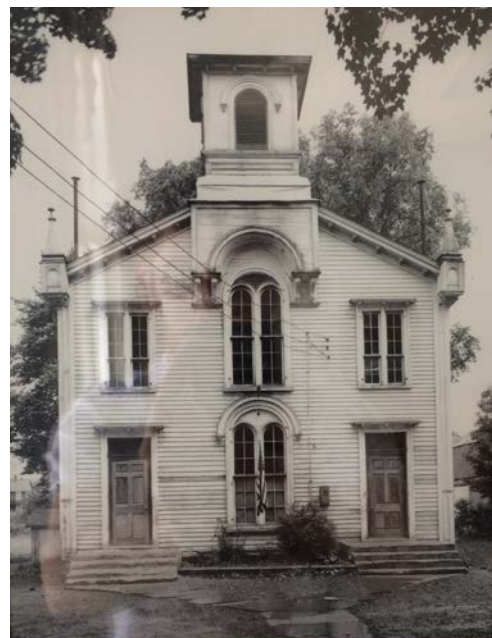
Figure 3. The District No. 2 School in 1912 (left) and 1959 (right)

Note the loss of shutters, change in front doors, addition of chemical bathroom piping on roof, and growth in surrounding foliage over time.

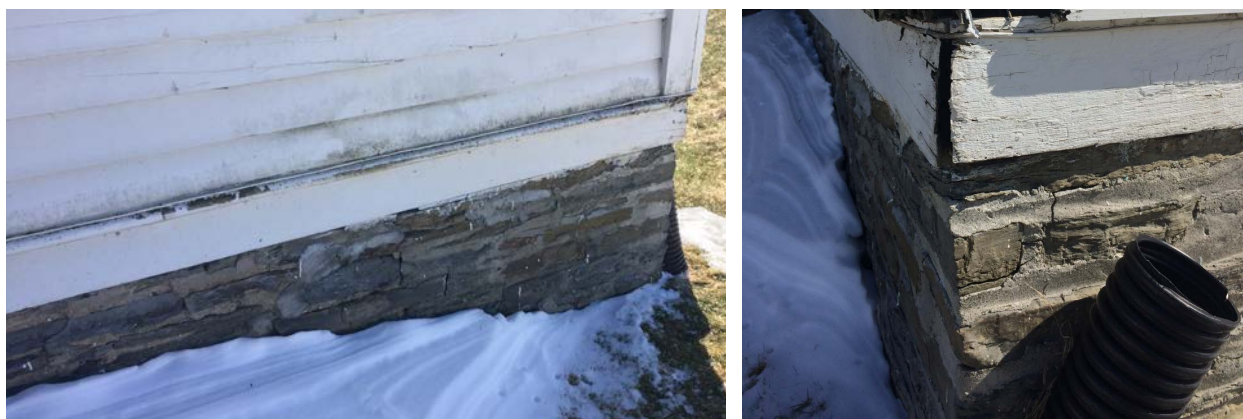
Figure 6. Foundation condition

The foundation is in good condition. The fieldstone is broadly intact, with only isolated instances of chipping and fracturing, and none of the mortars seem to be reacting negatively with the stone. The mortar work is in various states of degradation, making it difficult to discern the date and conditions of previous repointings. There is moderate biological growth along the foundation but no resulting damage to the stone or mortar.

Settlement in the northwest corner of the building has caused mild system cracking through the stone and mortar. This settlement has also pushed the foundation along the rear façade into misalignment with the wood frame sitting atop it. Additionally, settlement elsewhere in the building has pushed a limited number of stones out from flush with the rest of the foundation. Though these settlement issues are indicative of broader water management problems, they do not pose an immediate structural risk in themselves.

Note varied mortar types (left), small system cracking and settlement (right).

These estimates combine the sealing of the system crack on the northwest corner and the comprehensive repointing of the foundation mortar. At full-depth repointing estimated at \$10/sqft and the two-foot tall foundation extending along all 180 feet of the building's exterior, the estimate of \$3,600 assumes a complete repointing. The actual cost may be lower given existing mortar that may only need cosmetic repointing or minus the parts of the exterior that do not have exposed fieldstone.

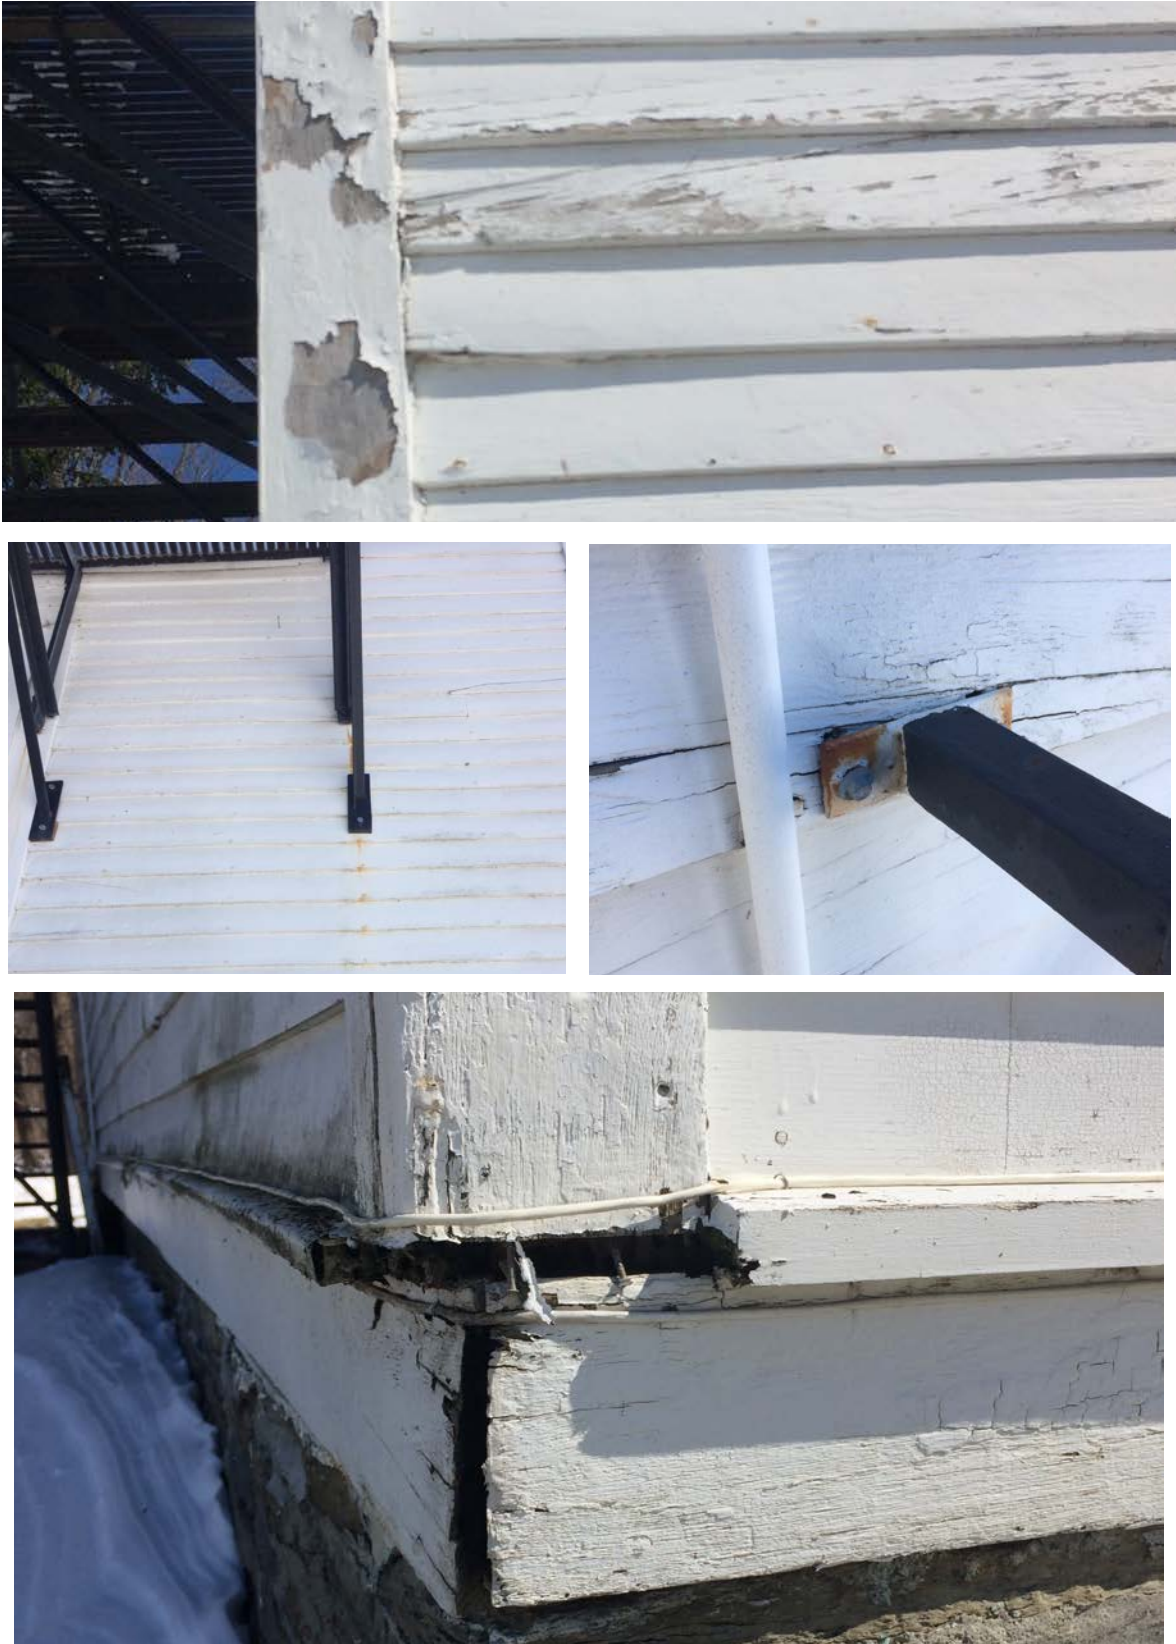
Figure 7. Siding condition

The building's siding is in fair condition, with extensive cosmetic damage but only isolated cases of damage to the wood itself. Much of the paint has failed, in several cases fully exposing the bare wood underneath. The most extreme case of paint failure is a large contiguous stretch of chipped and peeled paint above the cellar doors on the west façade, where significant black biological growth is also present. Extensive rust soiling is present as well, with vertical series of dots of rust soiling where the siding's nails were painted over. This is particularly distinct in the series of nails below the iron fire escape on the rear façade.

The clapboards are broadly intact, with checking along some of the boards made visible by resulting splits in the paint coating. More significant failures can be seen on the structure's northwest corner, where the corner boards and skirtboards have separated from each other, revealing failed fasteners in the open joint. There is widespread biological soiling along the skirtboards and lower clapboards, and while there are no signs of wood rot or structural mold damage there is the danger of such near cracks in these areas. Additional structural problems are visible at the connection of the iron fire escape to the wood siding, where instances of metal fasteners torqueing against the building have contributed to checking in the clapboards. There are limited instances of wood rot in the wood flashing at risk of degrading seriously if not treated.

(Clockwise from top) paint failure, checking, open joint and fastener failure, rust soiling

The cost estimate for the treatment of soiling from fasteners and biological sources was computed as one-eighth of the total siding needing conventional cleaning with eco-friendly products. The rationale in this estimate was that cleaning the limited soiling on the structure would be cheaper than the labor cost of scraping the affected paint off entirely. The use of eco-friendly products is an analog for the costs of avoiding harsh chemical cleaners to preserve the integrity of the historic materials, though only using water is always the best option for historic materials.

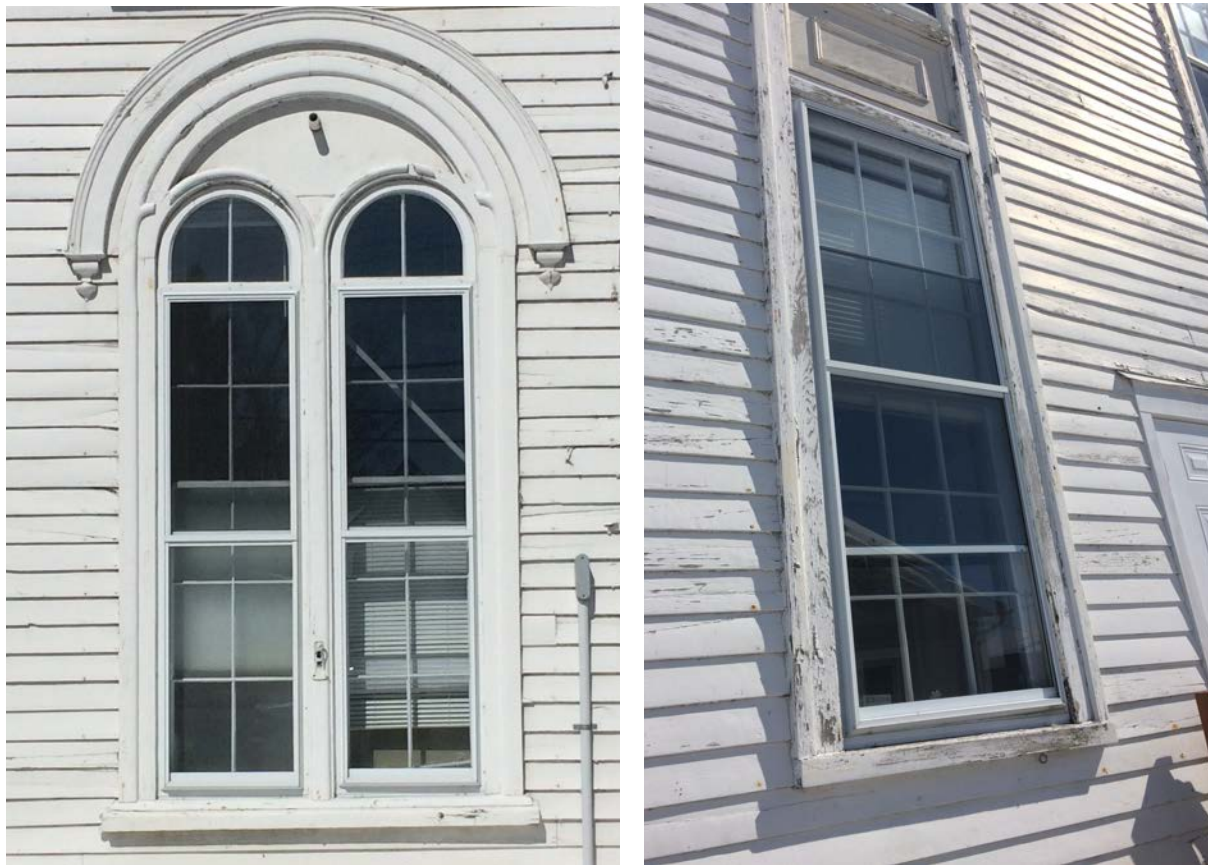
Figure 8. Window conditions

The building's windows are in good condition. The exterior casing, not replaced with the windows themselves, is typified by extensive cosmetic damage, with more severe paint failure than on the neighboring clapboard siding. The spandrel panels were not painted with the latest coat seen on the siding, still appearing as a light cream color. There are isolated spots of fastener-related rust soiling on the casings as well, though not as consistent as the rust spots on the siding. Additionally, the first story's double arched window appears to be missing wood in its casing elements. This is contrasted with the excellent condition of the window frames and rails, which exhibit no cosmetic or structural problems. The lack of structural damage evident in the window systems keep them classified as good rather than fair condition.

Missing molding pieces (left) and casing paint failure (right).

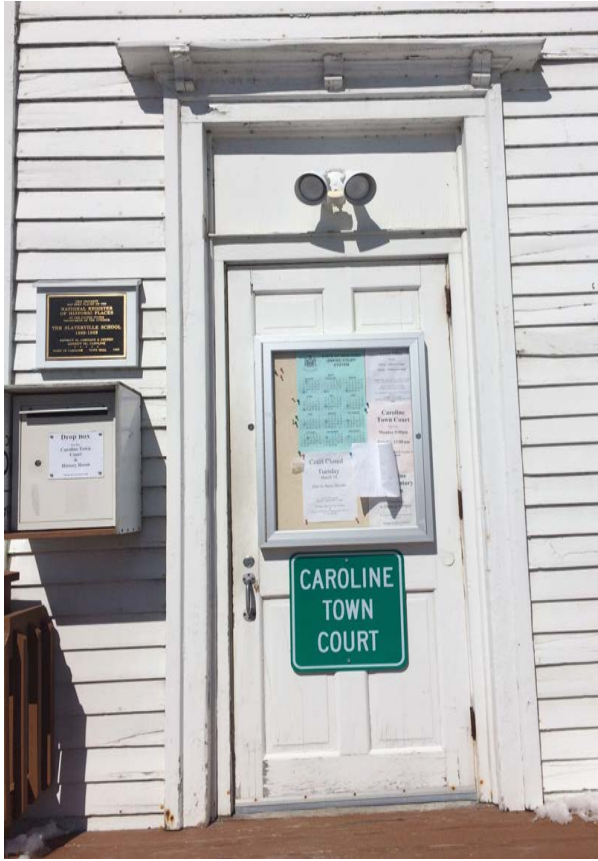
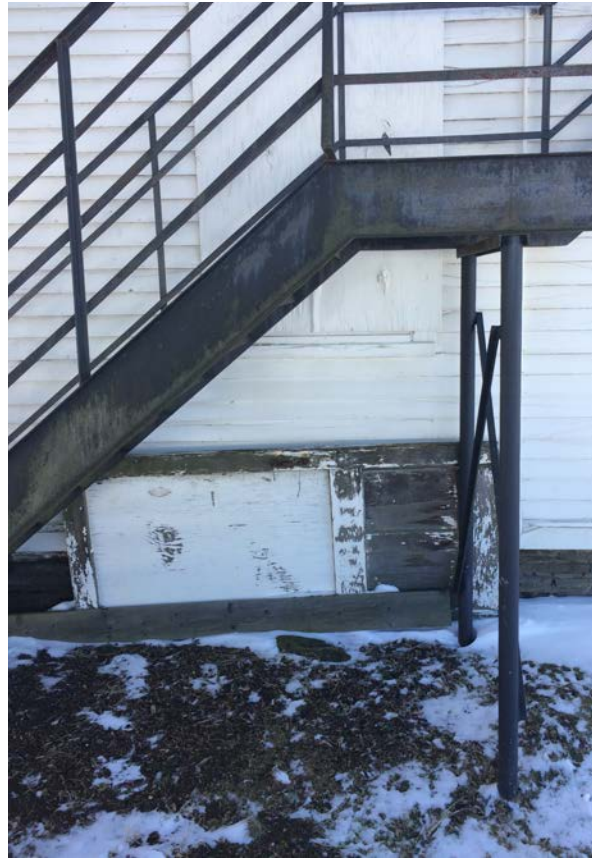
Figure 9. Door conditions

Similarly to the windows, the doors have all been replaced after the period of significance and are broadly in good condition. The doors exhibit mild cosmetic damages, though paint chipping and peeling is notably less prevalent than in the window casings or siding. The front doors' hinges have rusted, and their various metal fasteners have caused localized rust soiling on the paint. This contrasts the doors on the side façades, which appear to have newer rust-free hinges and only mild scuffmarks.

Though the wood and concrete stairs leading to the first story doors are in good to excellent condition, the iron fire escape on the rear façade is in fair condition. Rust and corrosion has occurred in the stairwell's corners, likely as a result of standing water or snow accumulation, and several of the fasteners connecting the stairs to the siding have corroded as well. This damage does not appear to be structurally dangerous but should be addressed as soon as possible.

Rust soiling (left) and removed door of unknown age and use (right).

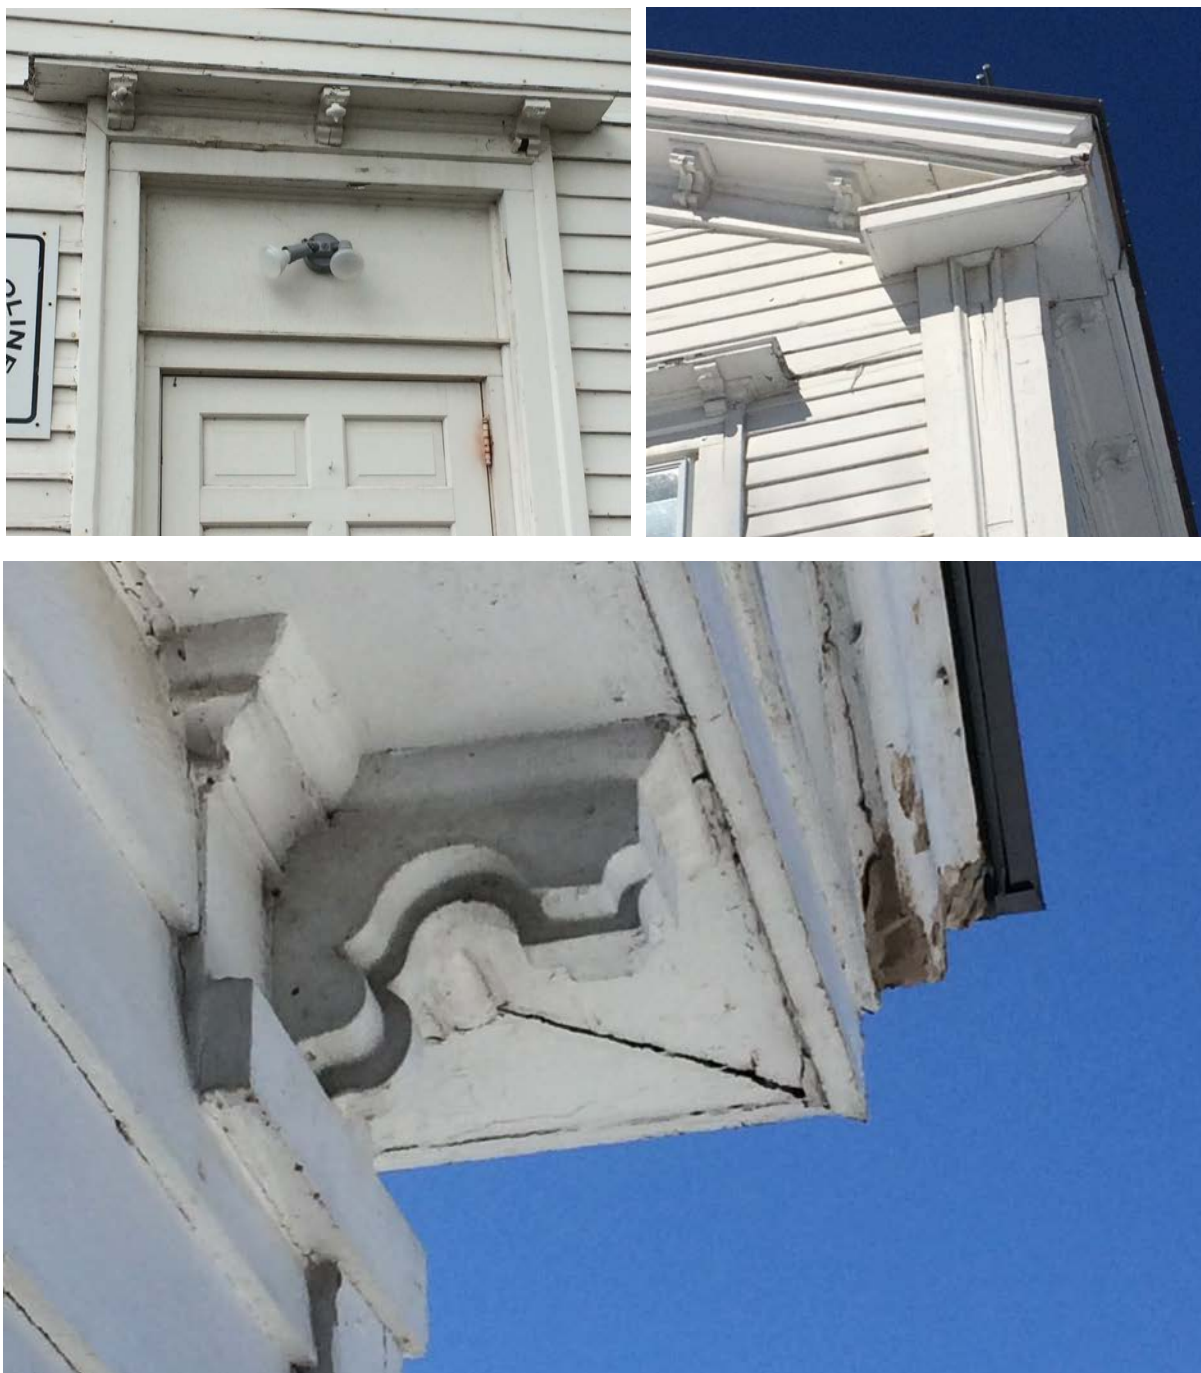
The ornamentation is in fair condition. The cornice bracket molding that follows the roofline exhibits paint failure, mild instances of open joints, and wood loss in several places. The causes of these problems is unclear due to a lack of access to the roof during this report but likely a result of wear-and-tear during the 2016 roofing project. There are several teardrop brackets broken or missing entirely from lintels on the front and side façades, as well as the aforementioned mismatched lintel beam above the left door on the front façade. The hand-painted sign on the front façade displays mild paint failure though still legible and intact. The square pilasters on the front façade's corner boards do not appear to have condition problems beyond those already mentioned in the siding section above.

Figure 10. Ornamentation condition
(Clockwise from top left) missing teardrop brackets, mild paint failure, and open joints and wood loss.

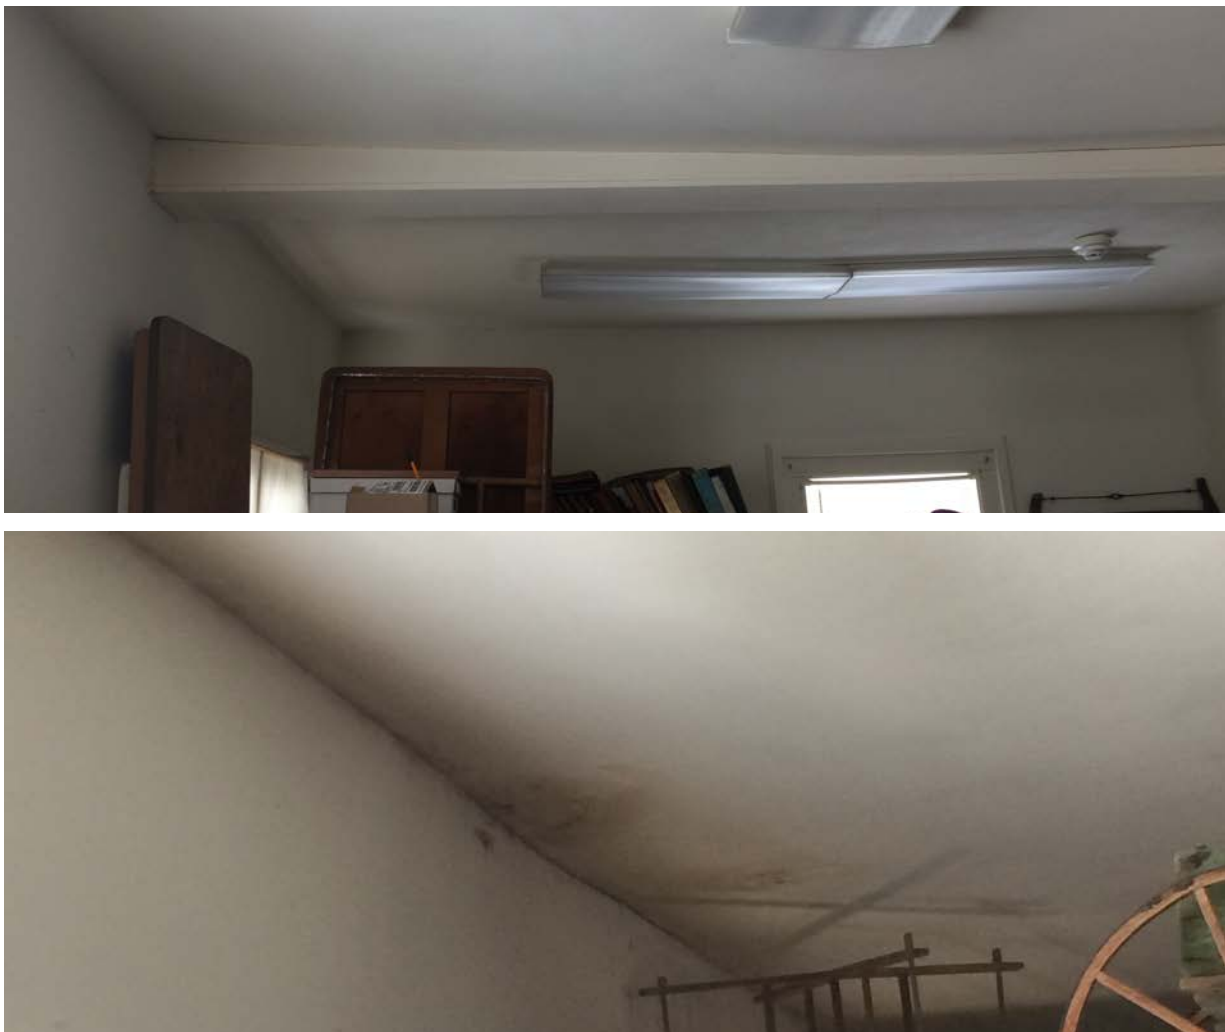
Figure 13. Second story interior condition

The second story spaces including the stairwell between floors were not included in the 2001 renovation, instead reflecting materials and alterations from the 1975 remodeling. These spaces are broadly in good condition but with two significant problems regarding the spaces' relationship with the building envelope. The ceilings of these rooms are bowed; an artifact of the weighty layers of asphalt roofing that existed until the 2016 roofing project. The removal of this weight should prevent further bowing in these spaces, but the recent nature of the roofing project obscures any informal metrics of further degradation. Also likely relating to the failure of the asphalt roof, there is water damage centrally on the western wall of the History Room and mild biological soiling along the top of all the walls and corners. This damage is less prominent in the second story office spaces than the History Room but still present, if less severe.

Bowed ceiling (top) and water damage and biological growth (bottom)

The biological soiling in the second story interior spaces should be treated reasonably soon to create a baseline condition for observing the efficacy of the new roof in stopping the infiltration of water through the building envelope. The soiling can be treated through the gentle application of water and if necessary detergent. Though the materials of the interior spaces are not historically significant, harsh chemical cleaners should be avoided to preserve the condition of the materials.

The provided cost estimate includes the costs of a full treatment and patch for the water damaged section of drywall in the History Room's ceiling. If this is not deemed necessary upon closer inspection, the costs for this recommendation can be expected to be much lower.
