Town of Caroline Highway Facilities Project

852/866 Valley Road, Brooktondale, NY 14817

DUE DILIGENCE REPORT FINAL DRAFT

FEBRUARY 11, 2020

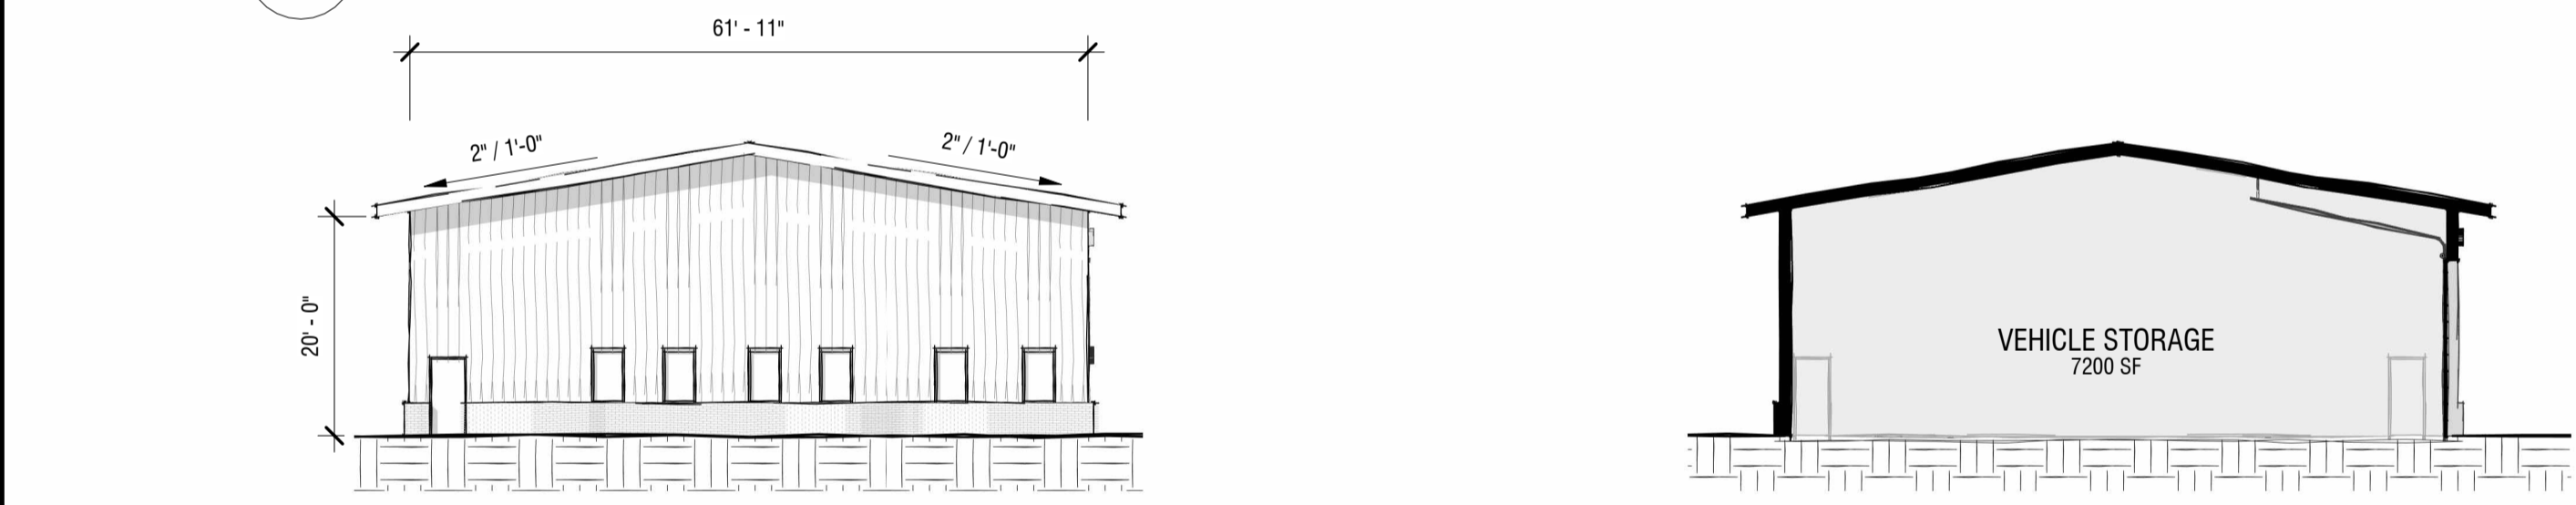
5 CONCEPT 2 - SIDE ELEVATION

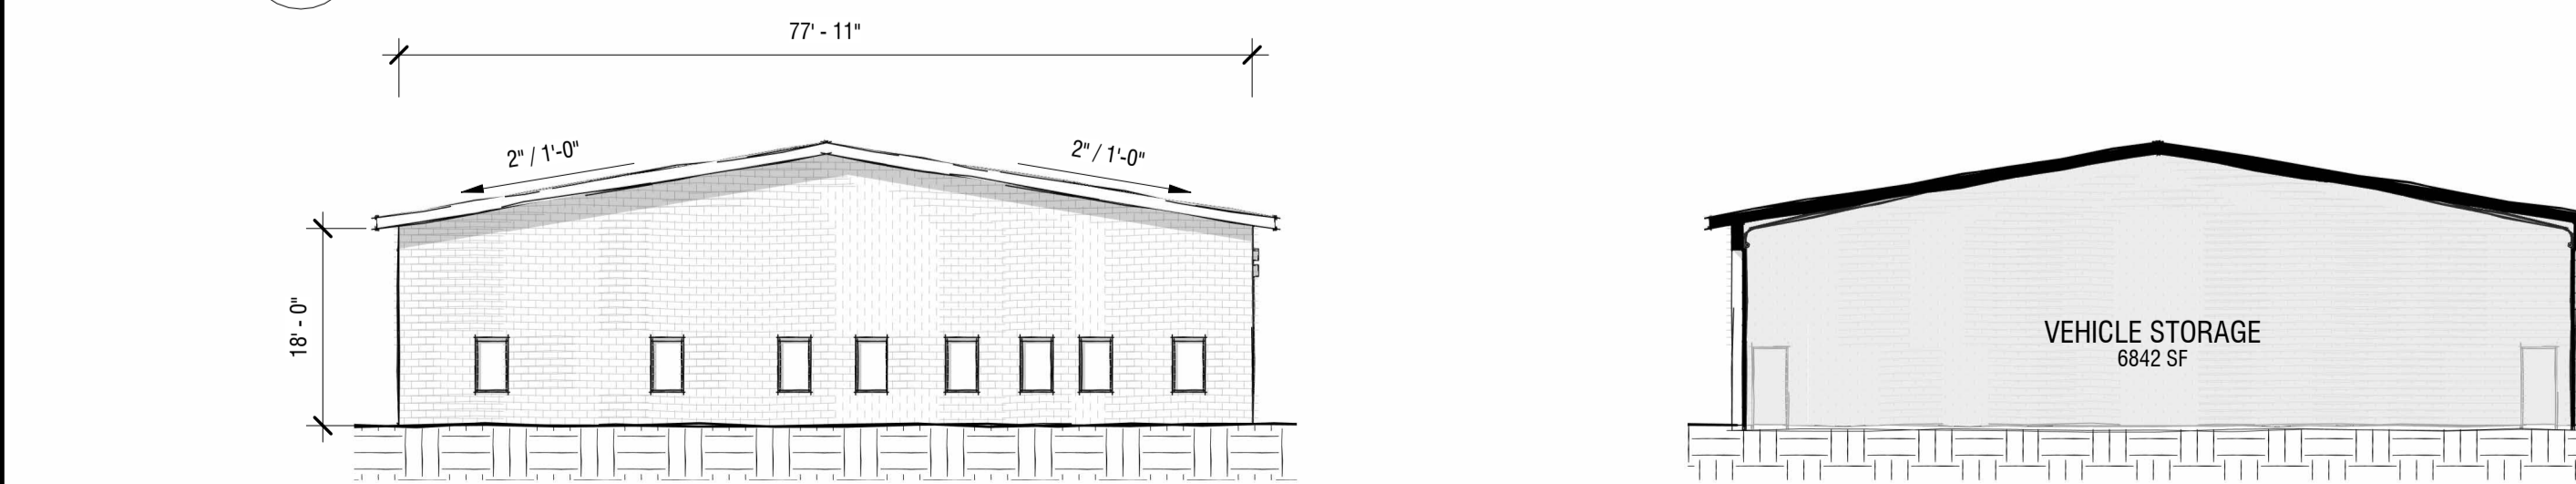
8 CONCEPT 3 - SIDE ELEVATION

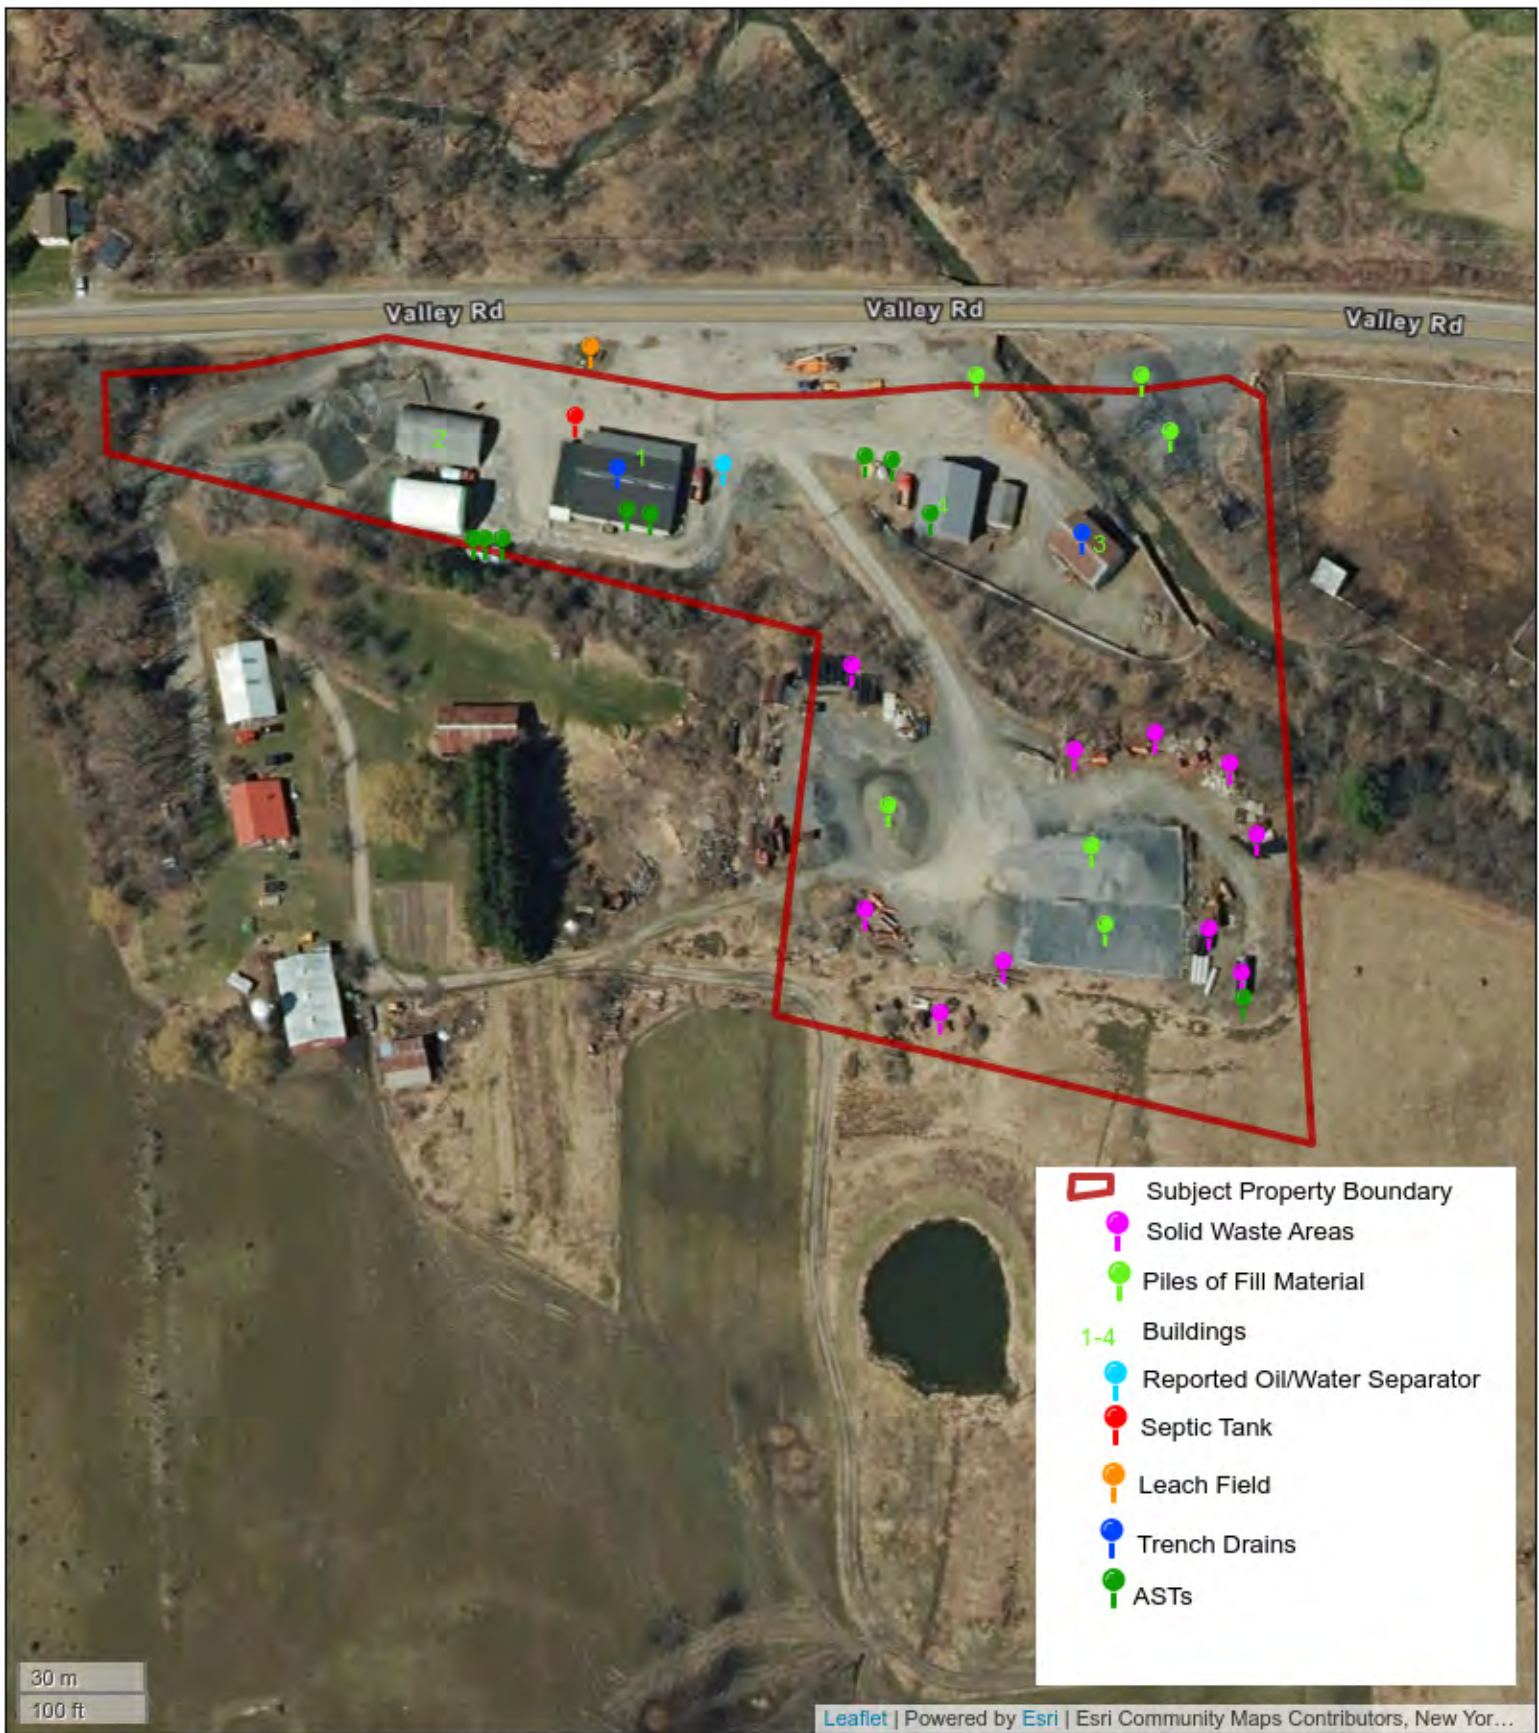
Figure 3 Site Plan
 852-866 Valley Road
 Brooktondale (Town of Caroline), New York 14817
 Project No. 2232578

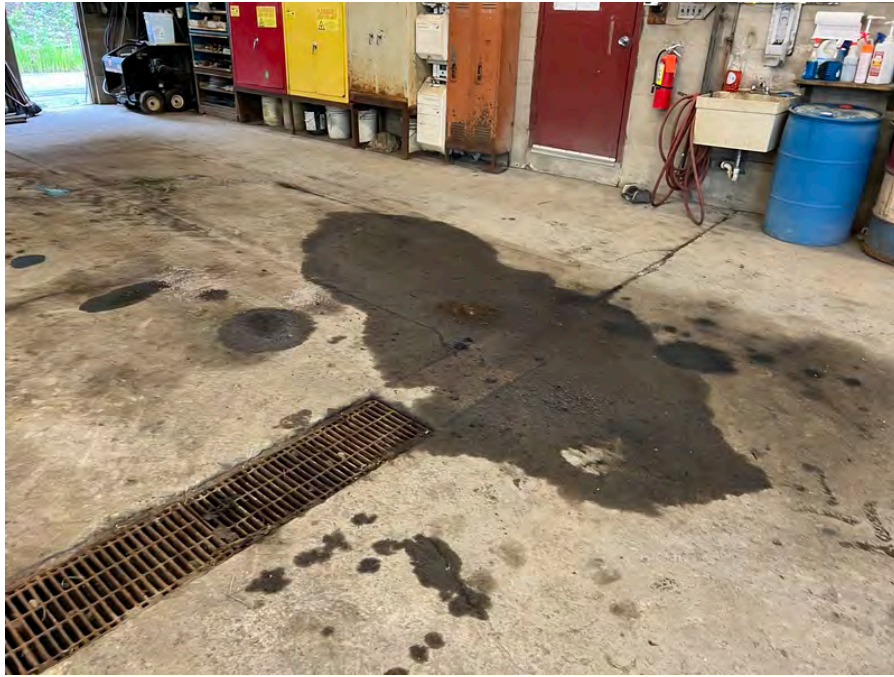
Photo 17 : Representative staining in Building One

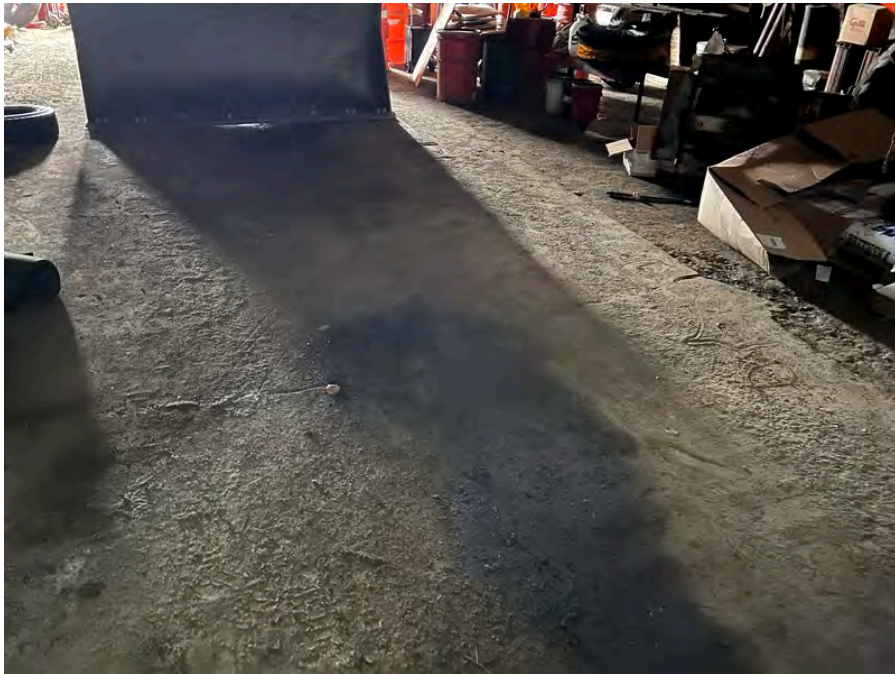
Photo 22 : Representative staining in Building Two

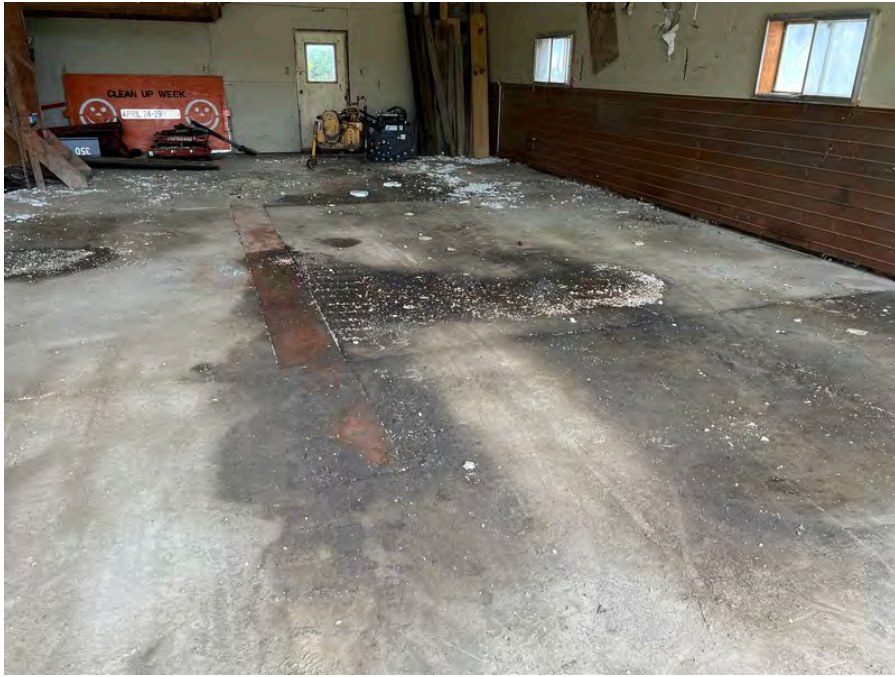
Photo 31 : Representative staining in Building Three

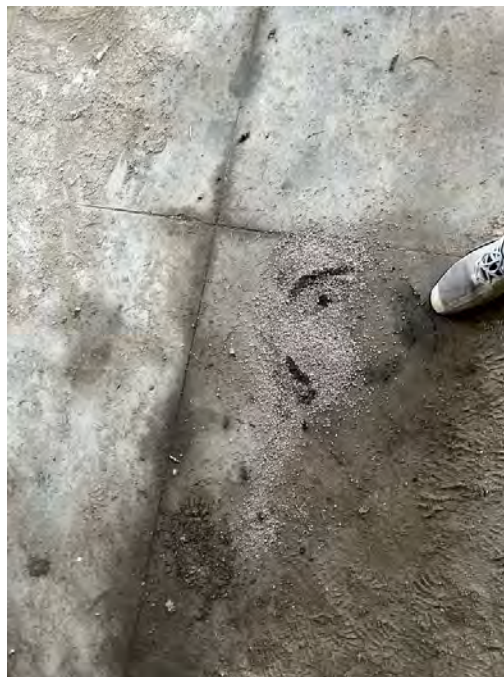
Photo 38 : Representative staining in Building Four

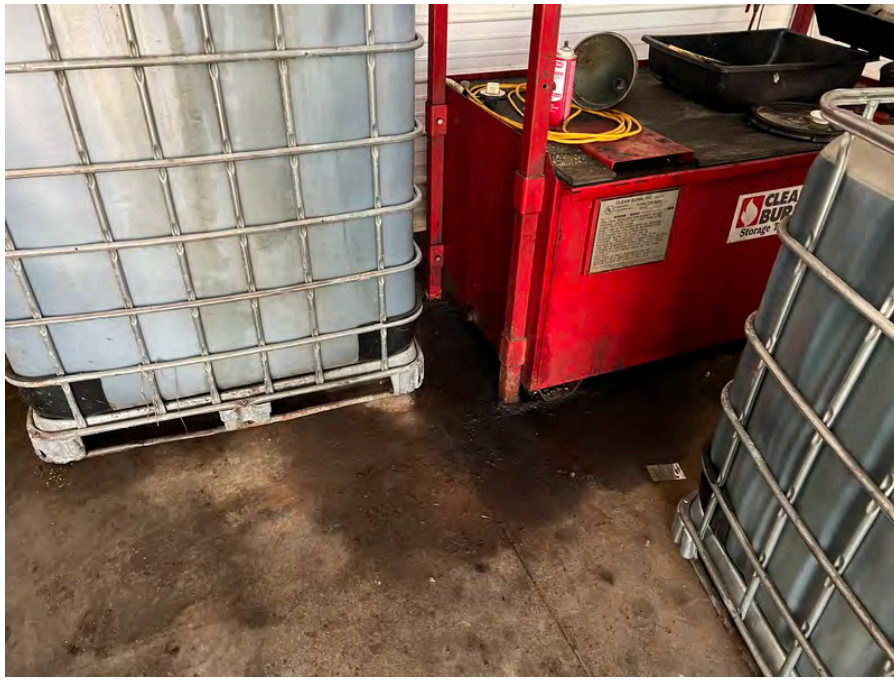
Photo 43 : Staining proximate AST in Building Four

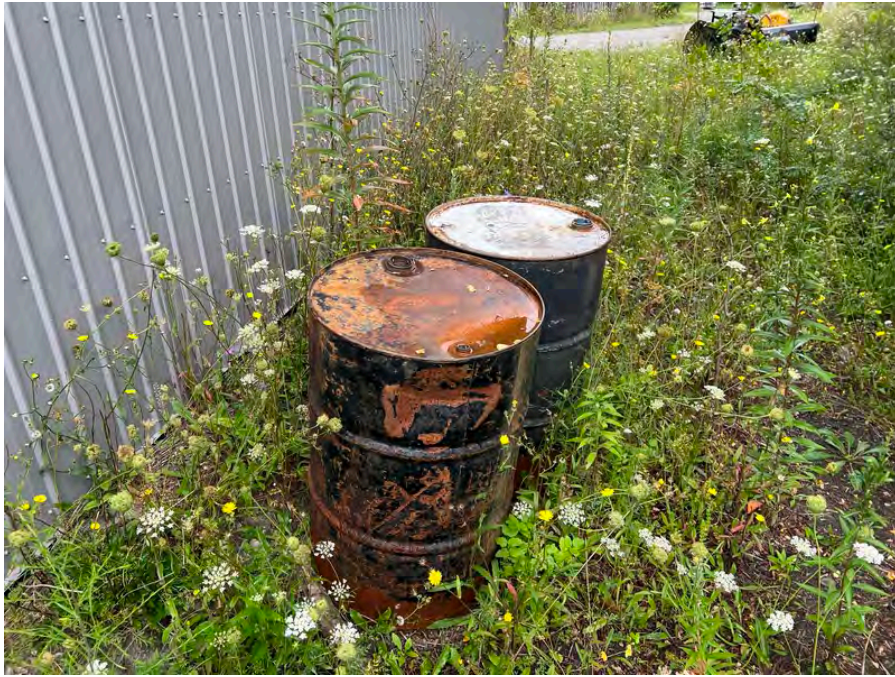
Photo 49 : Empty corroded drums on southern exterior of Building Four

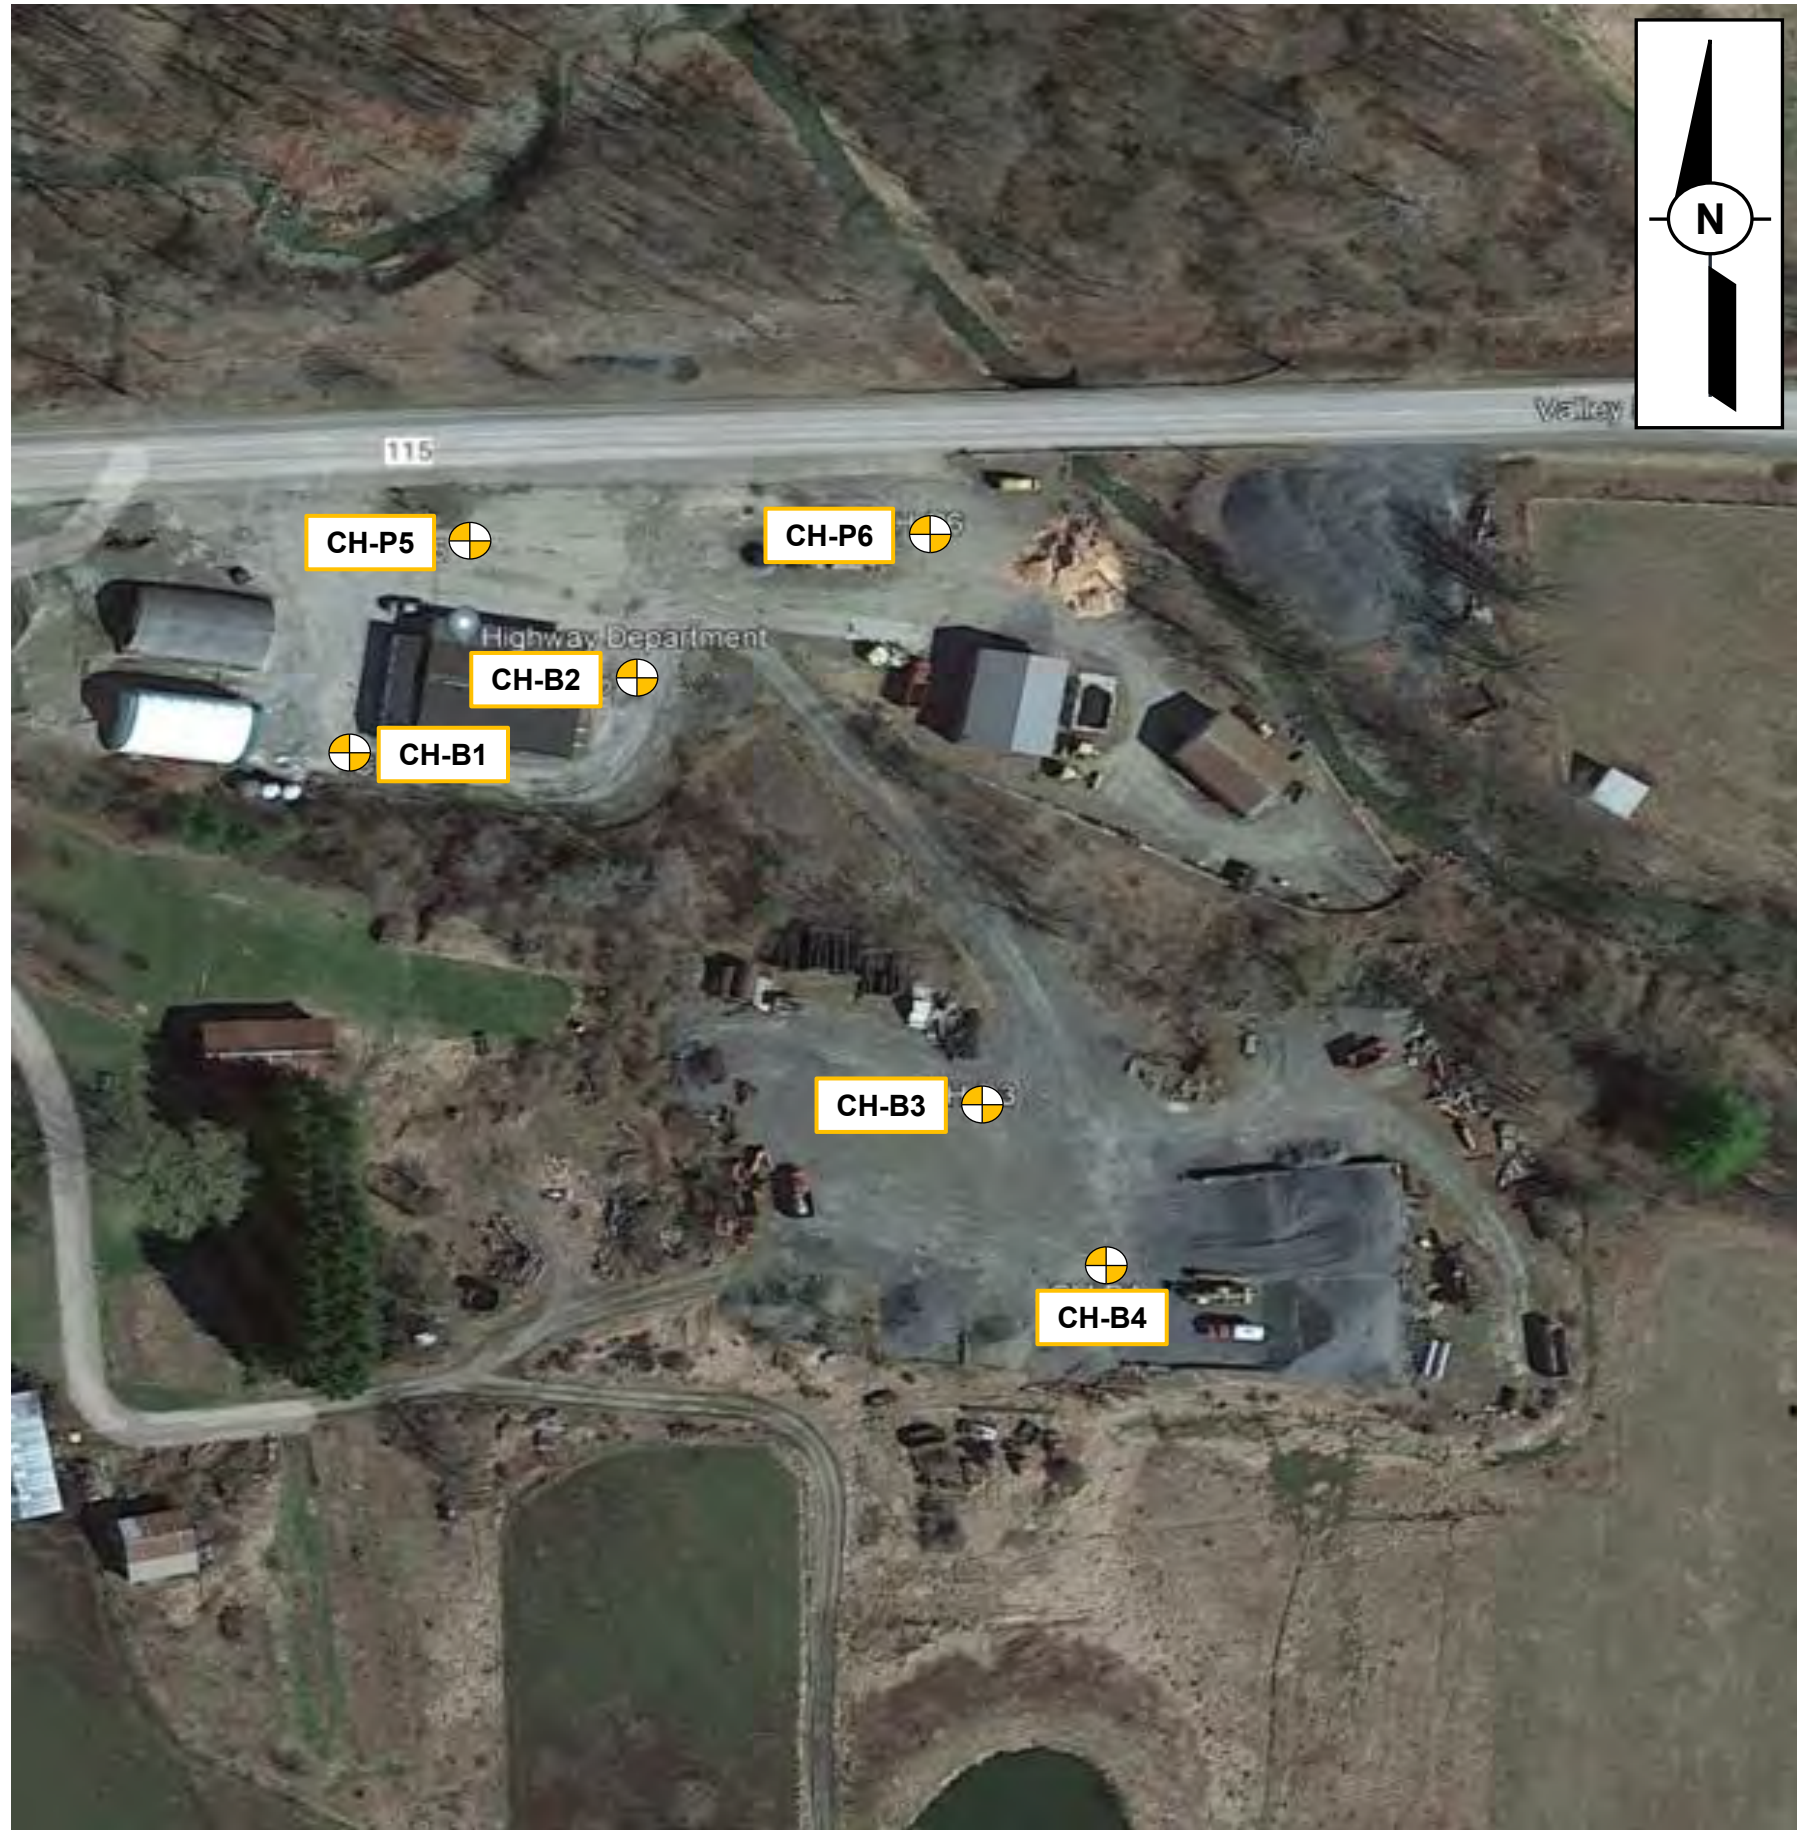
TEST BORING & DESIGNATION

EXPLORATION INFORMATION			
Boring	Northing	Easting	Elev.
CH-B1	42.3857	-76.3644	1075
CH-B2	42.3858	-76.3639	1075
CH-B3	42.3852	-76.3633	1111
CH-B4	42.3850	-76.3631	1115
CH-P5	42.3860	-76.3642	1075
CH-P6	42.3860	-76.3633	1075

GEOTECHNICAL SUBSURFACE INVESTIGATION

The subsurface exploration indicates that at Test Boring CH-B3 this portion of the site is favorable for shallow foundations; **however, the area surrounding Test Boring CH-B4 contains soft clays which will most likely not be able to support a commercial structure and the associated loading without settlement issues.** For the area surrounding Test Boring CH-B4 LaBella recommends that the proposed structure foundation should consist of a deep foundation such as screw piles (e.g., helical piles, drilled-in displacement mini-piles). It should be noted that depending on the final building layout and orientation additional Test Borings may be required to determine the extent of the soft clays.
