DISTRICT No.2 SCHOOL

TOWN OF CAROLINE
TOWN HALL

Slaterville Springs, NY
Historic Structures Report

Prepared by Sam Coons

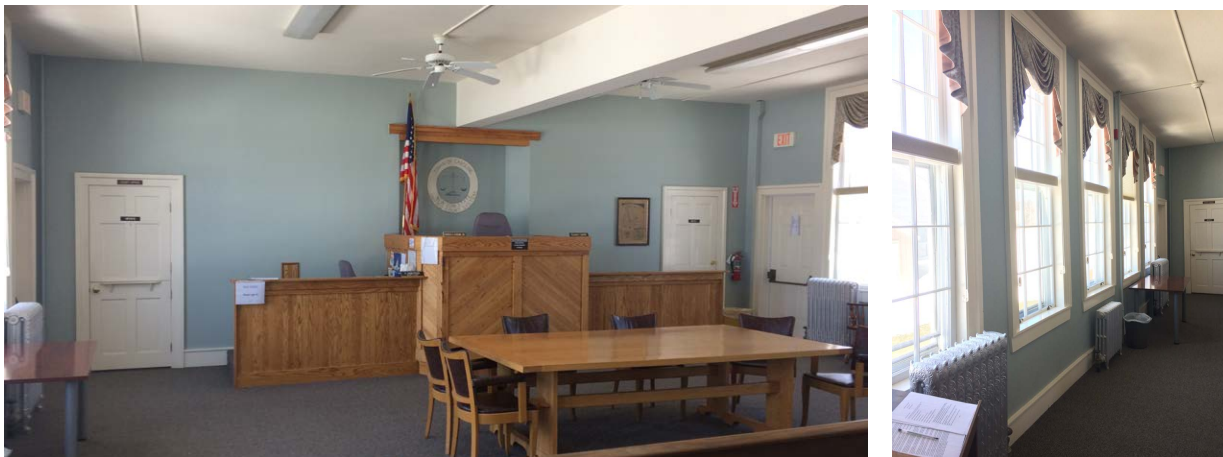
Figure 11. Interior of first story courtroom

The first story interior spaces are in excellent condition. The courtroom is very well maintained, having been renovated in 2001, though is typified by a deviation in form and decoration from the original two-schoolroom setup during the period of historical significance. Paint, carpeting, interior windows and casing, and doors are all in excellent condition both in the courtroom and in the small storage/break room stemming from the foyer. None of these elements beyond the windows appear consistent with historical photographs.

Viewed from front entrance looking north; note beam dividing the space lengthwise in half.

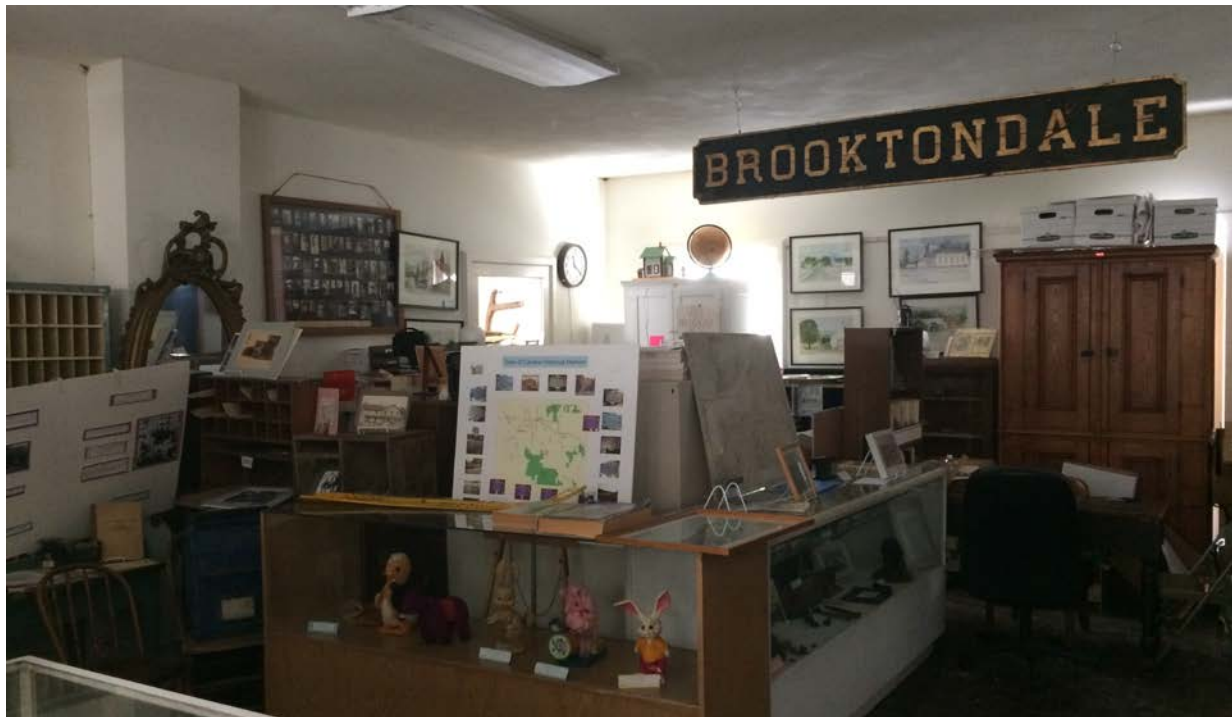
Figure 12. Interior of second story History Room

Facing west wall; space to the right of this view is used for storage.
